Problem - Traction inverters

Objective - Discover the root cause

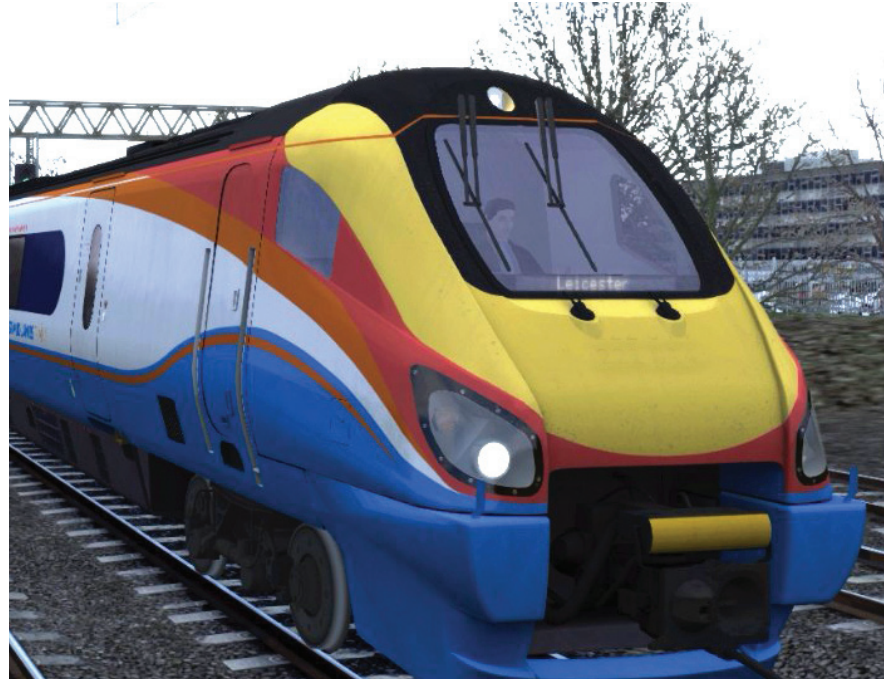
SET carried out two weeks of intensive reverse engineering and tests, which led to discovery of the root cause: a degrading internal connection within the main power switching devices (IGBTs), leading to false error detection.

- Custom test devised to detect the issue at an early stage.
- Failing IGBTs replaced with alternative batch.
- SET took over repair service from OEM
