SPECIALISTS IN ELECTRONIC & ELECTROMECHANICAL ROOT CAUSE FAULT FINDING AND RESOLUTION

Problem - Traction inverters

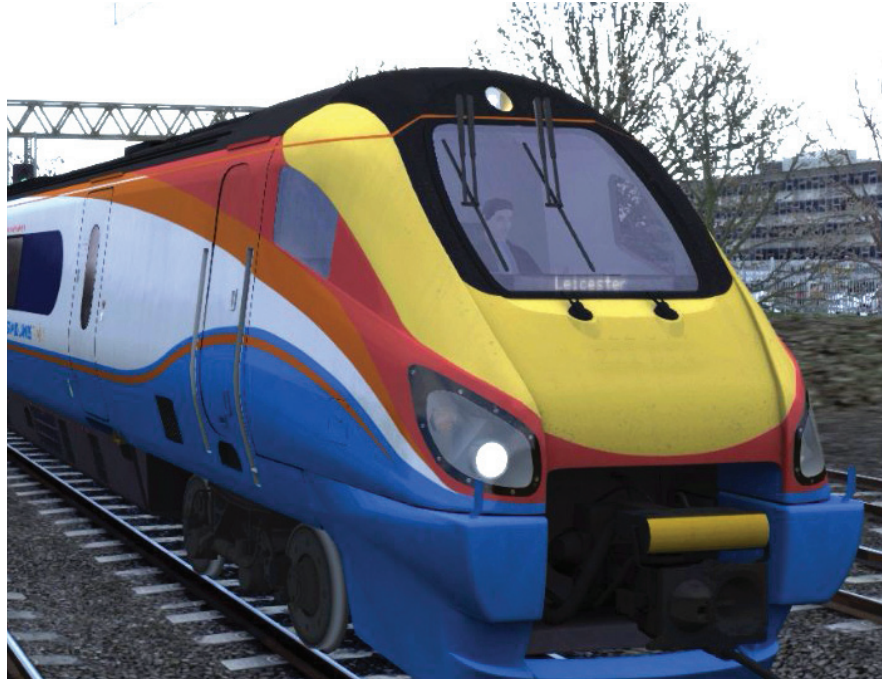
In 2010 equipment was showing intermittent 'turn-on/off' faults repeatedly resulting in isolation. This had become a long-standing problem.

Equipment was being returned to the OEM, only to be returned 'NFF', despite the fault continuing to be present when returned to service.

SET carried out two weeks of intensive reverse engineering and tests, which led to discovery of the root cause: a degrading internal connection within the main power switching devices (IGBTs), leading to false error detection.

- Custom test devised to detect the issue at an early stage.
- Failing IGBTs replaced with alternative batch.
- SET took over repair service from OEM

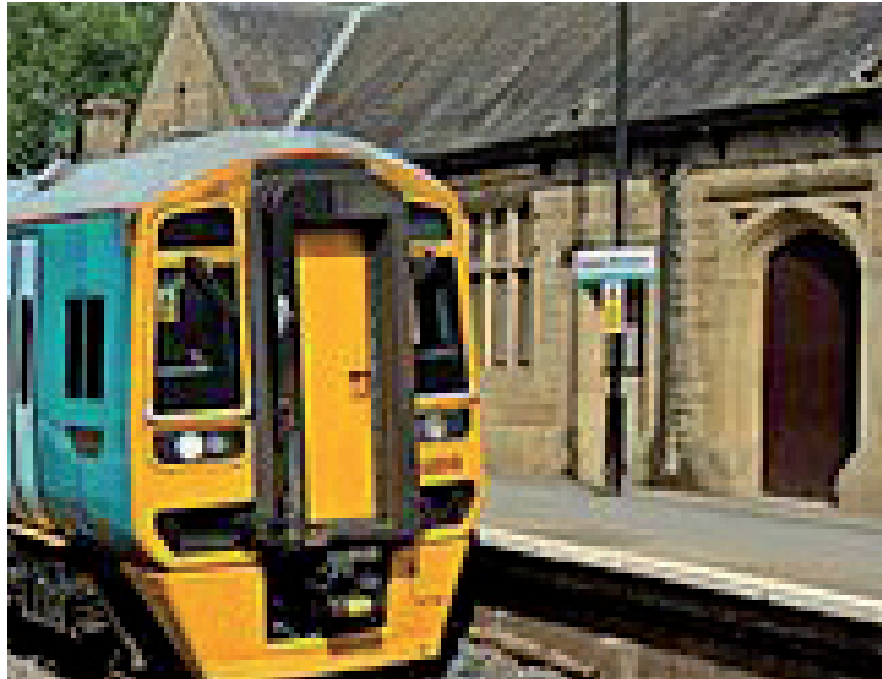
- Existing supplier to our customer unable to meet delivery needs - Trains stopped.
- High re-failure rate with existing supplier.

- Equipment reverse engineered to produce technical documentation and test procedure.
- Motor-alternator set built to provide required test environment and ensure that safety critical aspects could be fully verified.
- Weaknesses identified and overhaul programme devised.

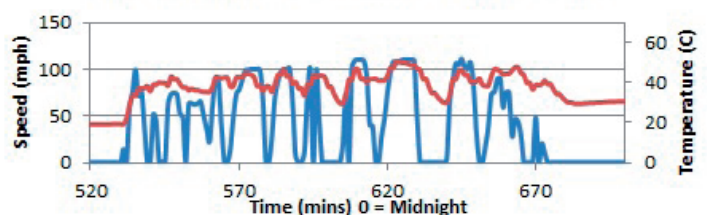
Speed and Heatsink Temperature

- Two alternatives validated via on-vehicle trials including EMC & Thermal.
- Lab tests to demonstrate operation within design limits.
- Duty cycle tests to predict service life.
- Close links established with component manufacturers to ensure all technical requirements & risks were understood. This also allowed SET models and predictions to be independently scrutinised.

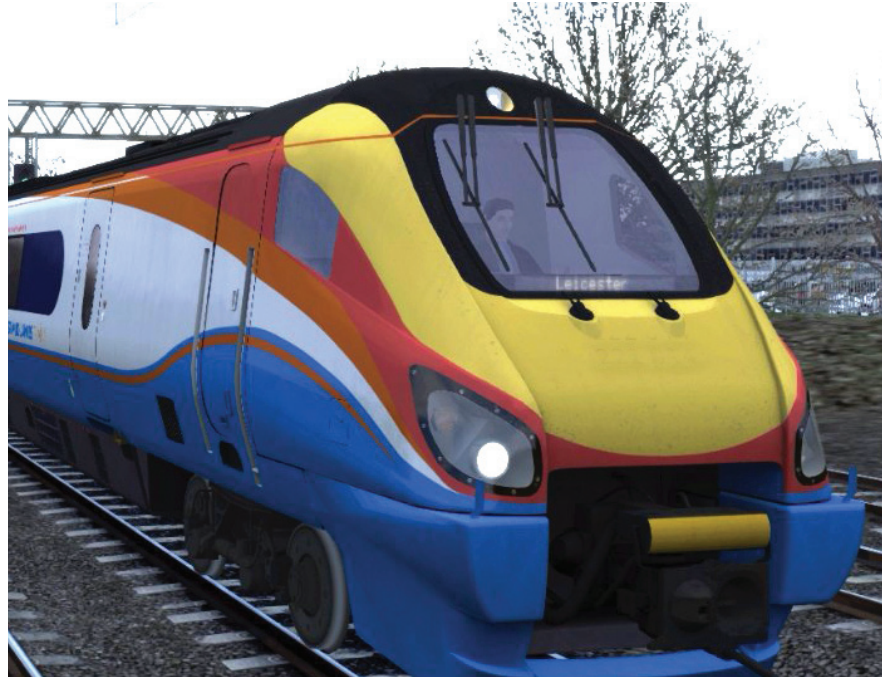
Hot axle box sensors failing partially – leading to triggering of alarm but without positive evidence of overheating. The cause and significance of this was uncertain. Service minutes were being lost.

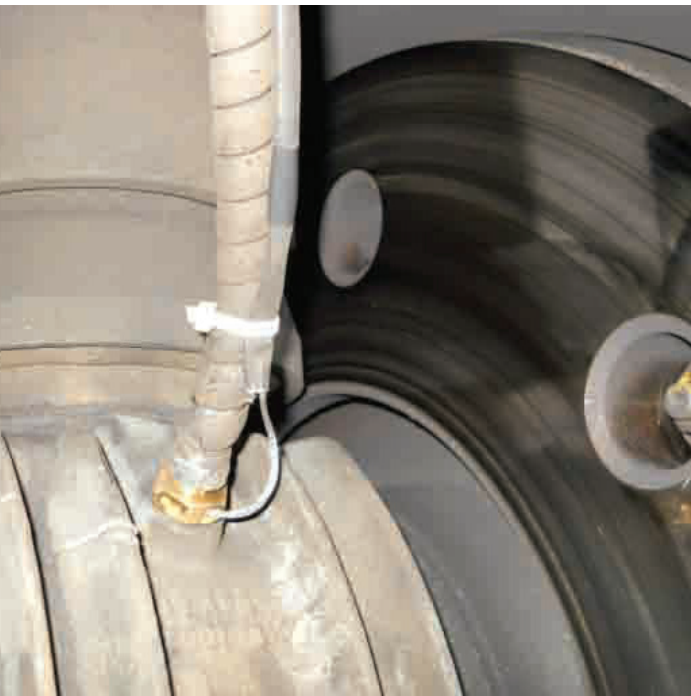
Live data logging equipment installed on vehicle in targeted locations

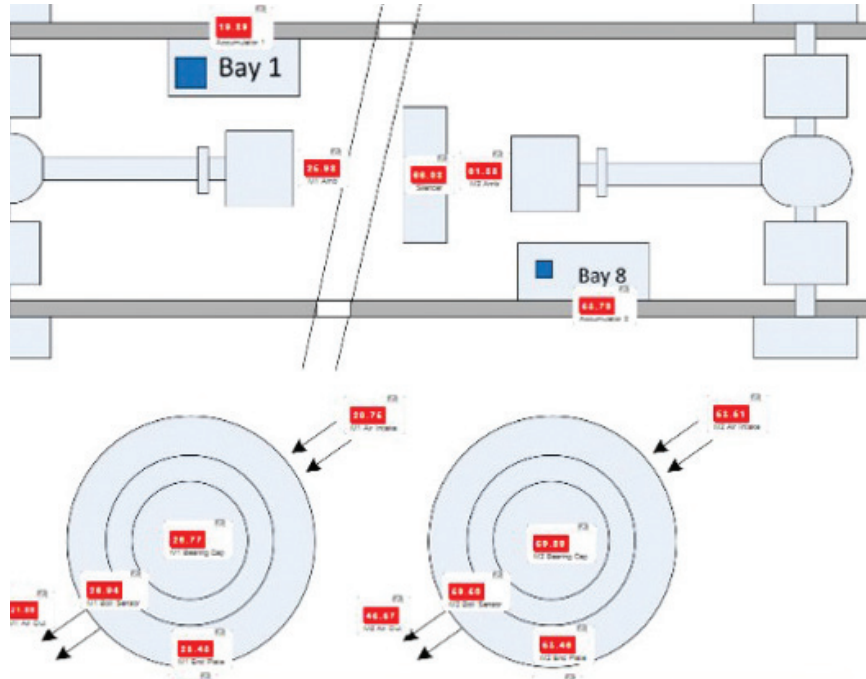
Bearing on the motor was failing prematurely in certain vehicle locations

There was uncertainty as to whether temperature was a contributory factor (this was the element SET was asked to investigate)

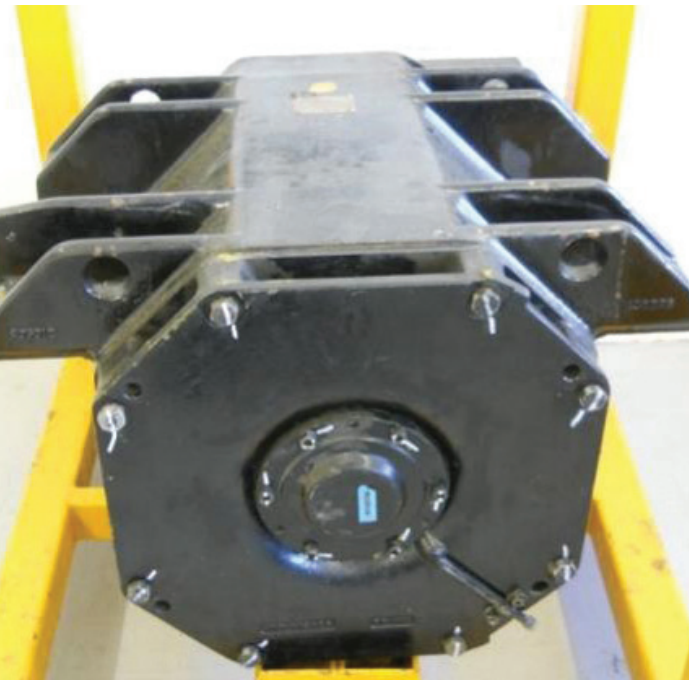
- Exhaust silencer eliminated as contributory factor (an early theory based on proximity of exhaust to bearing cover)
- Inadvertent heating of motor air intake identified as an issue

- Custom sensors produced for each location, and installation method developed to allow on-vehicle installation process
- Data logger enclosure with high impact resistance and additional robustness added by modifying underframe bay door
