# CASE STUDY

### SPECIALISTS IN ELECTRONIC & ELECTROMECHANICAL ROOT CAUSE FAULT FINDING AND RESOLUTION

### **Problem - Exploding Bus Bar Capacitors**

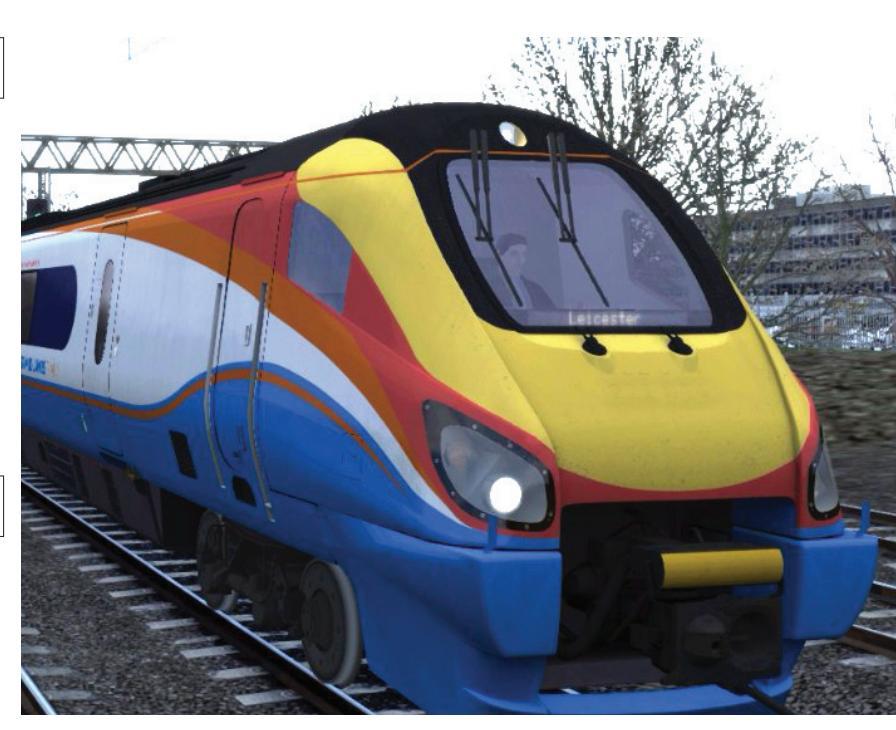
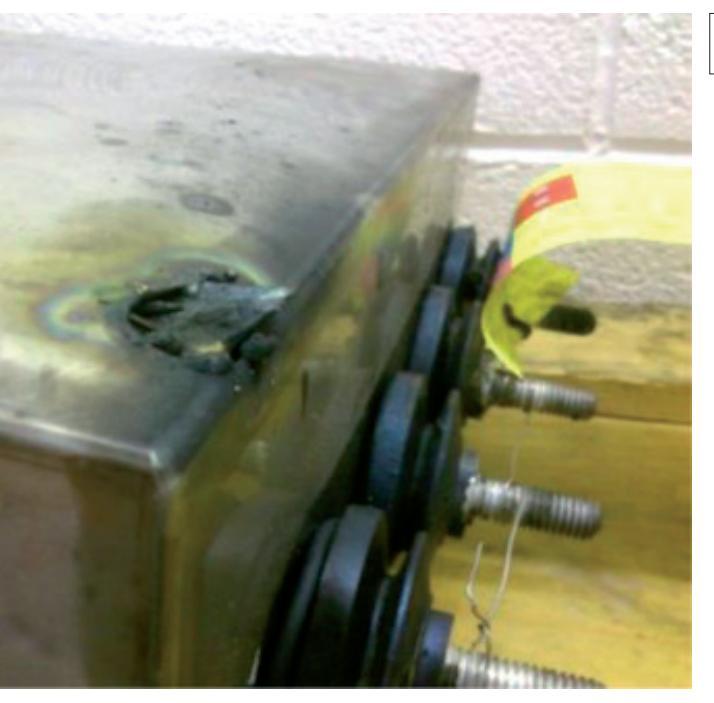
- Violent rupture of case of main reservoir DC link capacitors supplying the traction inverters (1000V).
- The released material caused significant collateral damage to the main bus bar and to the associated traction inverter.
- Similar failures had previously been investigated by the OEM, but the customer wanted an independent opinion; to understand the cause and whether any preventative measures could be taken.

Typical failure modes examined against visual evidence of the failed capacitor. Several hypotheses were proposed and examined.

- Most likely reason for failure was identified along with possible aggravating factors.
- Recommendations given for further investigation, inspection and monitoring methods.

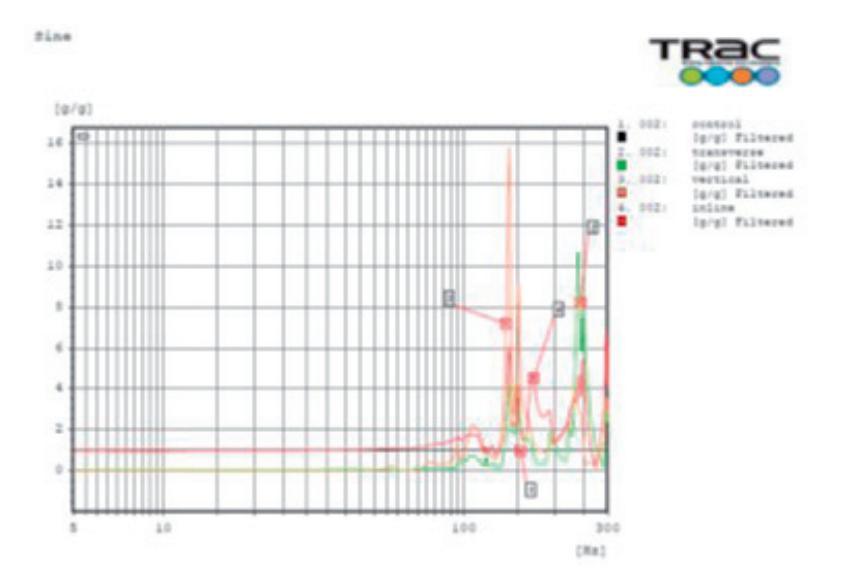
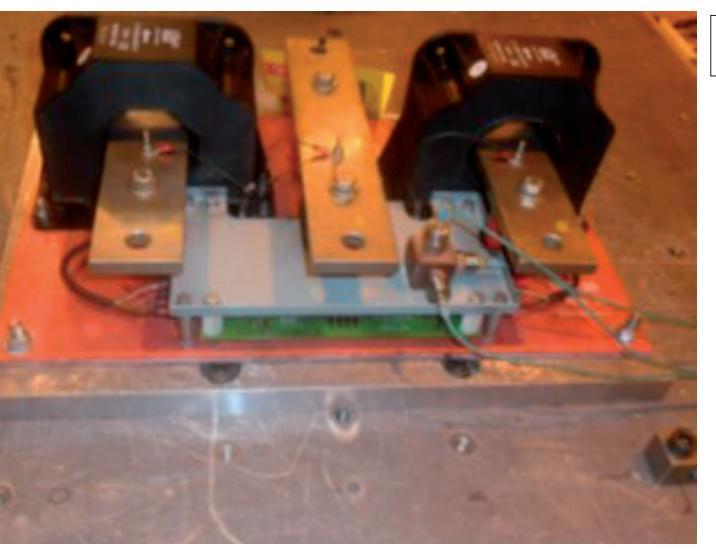
Failure rate of traction motor monitoring panel was increasing, causing service disruption

- Fault was traced to cracking of internal PCB in a voltage monitoring device (VMD) fitted to the monitoring panel main PCB.
- SET conducted vibration testing of the panel to verify hypothesis that resonance of the panel was capable of causing the observed cracking. Tests indicated that the VMD was seeing vibration levels far in excess of those specified for the device when tested at levels specified in EN61673.
- Tests indicated that a previous modification made by the OEM had reduced low frequency flexing of the main PCB but had not addressed the higher frequency resonance and had introduced new resonance modes

Report with recommendations on design changes (verified during tests) to bring vibration levels at the VMD within its specified range

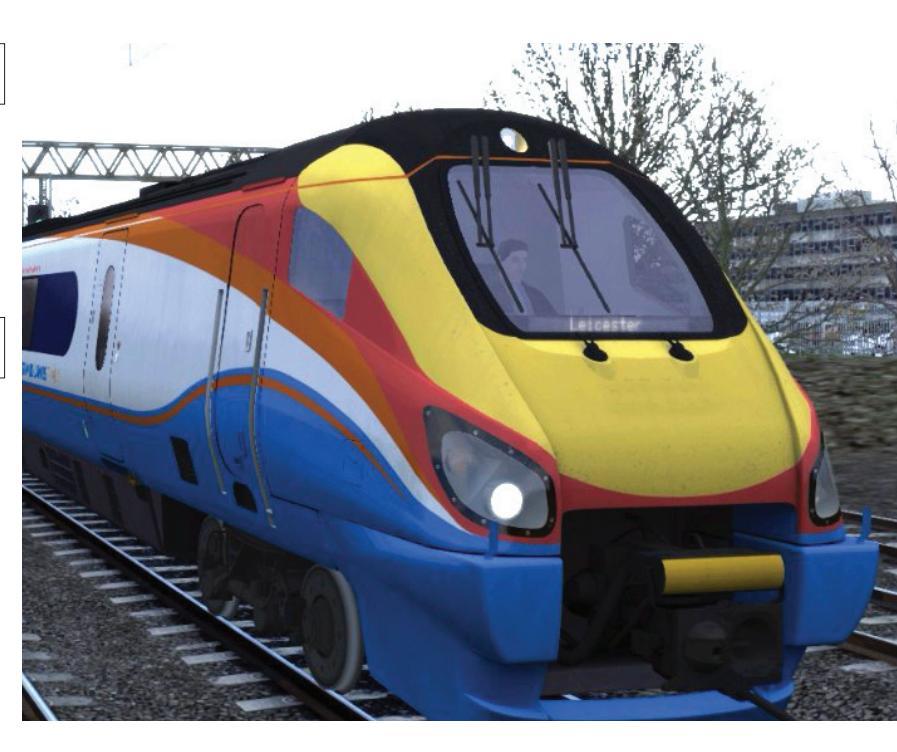
Extensive investigation of units with intermittent faults revealed micro-cracking of joints around a Zener diode only visible under magnification.

Cracking was caused by thermal cycling of the device (heats each time vehicle accelerates) resulting in cyclic stresses in the solder joints and ultimately fatigue fracturing

- causing intermittent electrical connection.

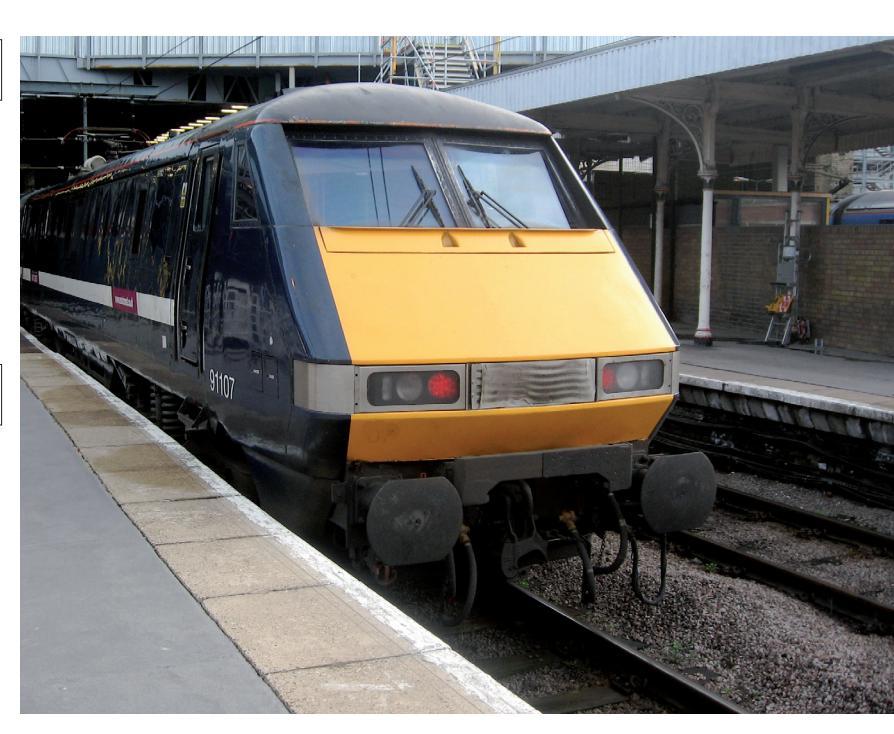
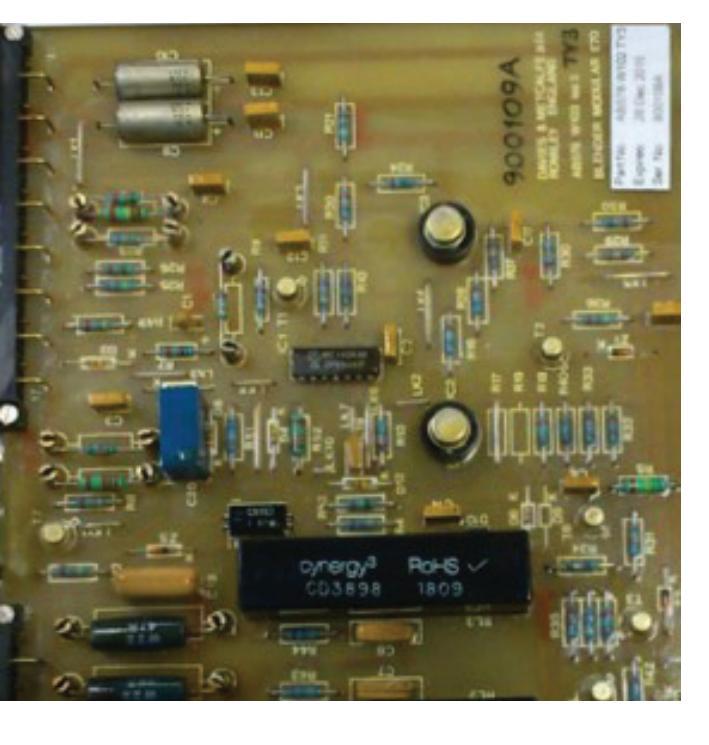
Failing relays on brake blender and other interface panels resulting in service interruptions

- SET engineer stationed at customer's service depot to enable overhaul to be carried out on-site to eliminate transport delays
- Custom test equipment created to ensure fully functional units were returned to customer, including functional areas not affected by the component replacements

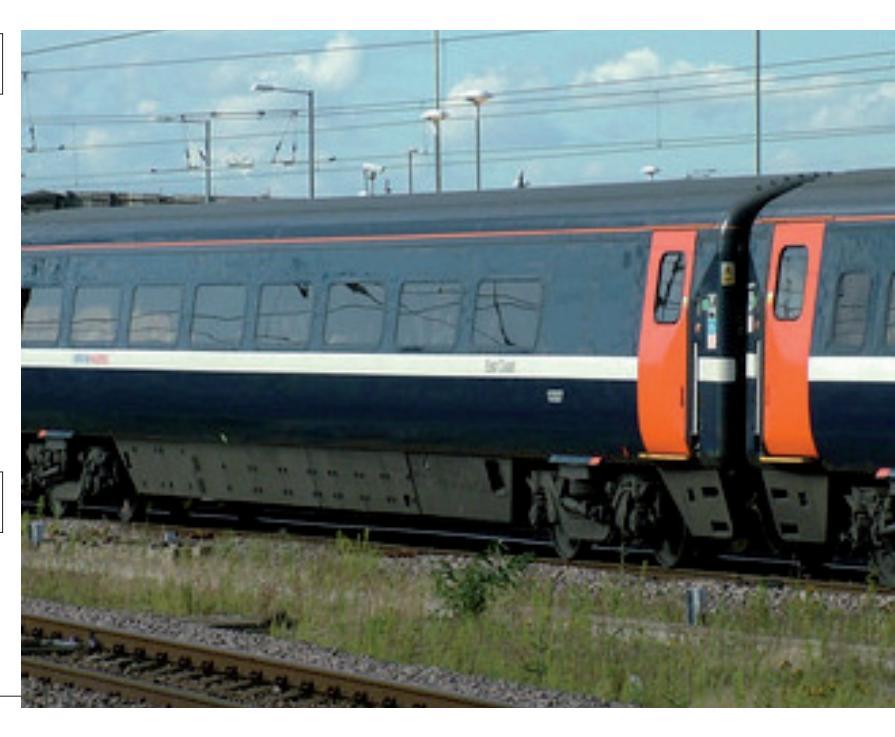
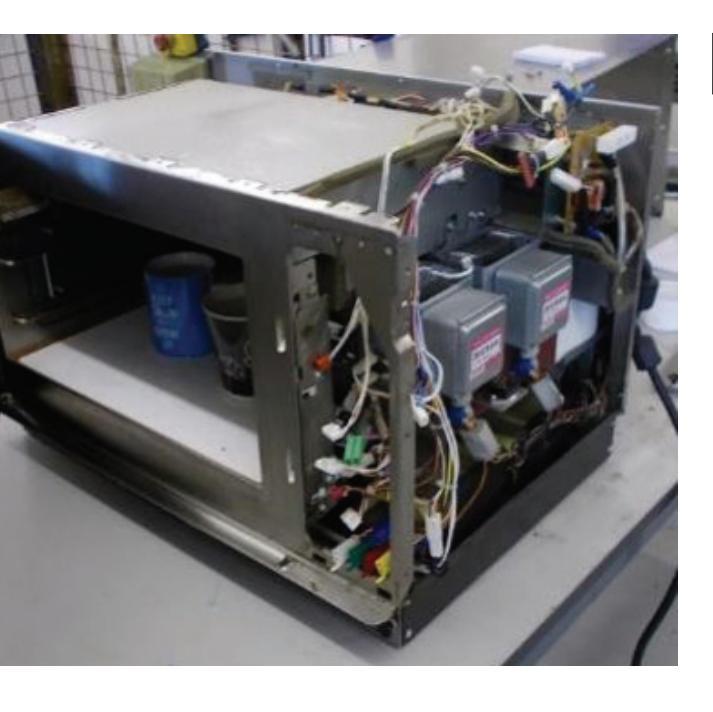
The problem addressed by the modification was that cooking cycles of microwave catering ovens were being interrupted by power supply drop outs causing the programmer to be reset. This had resulted in catering delays and wasted food.

Sample microwave reverse engineered to produce schematics and to understand the interface and interaction with the programmer

- PCBs and assemblies created
- Comprehensive modification procedure defined to ensure that electrical and microwave safety were not compromised by the modification, as well as ensuring that the desired interrupt rejection was achieved

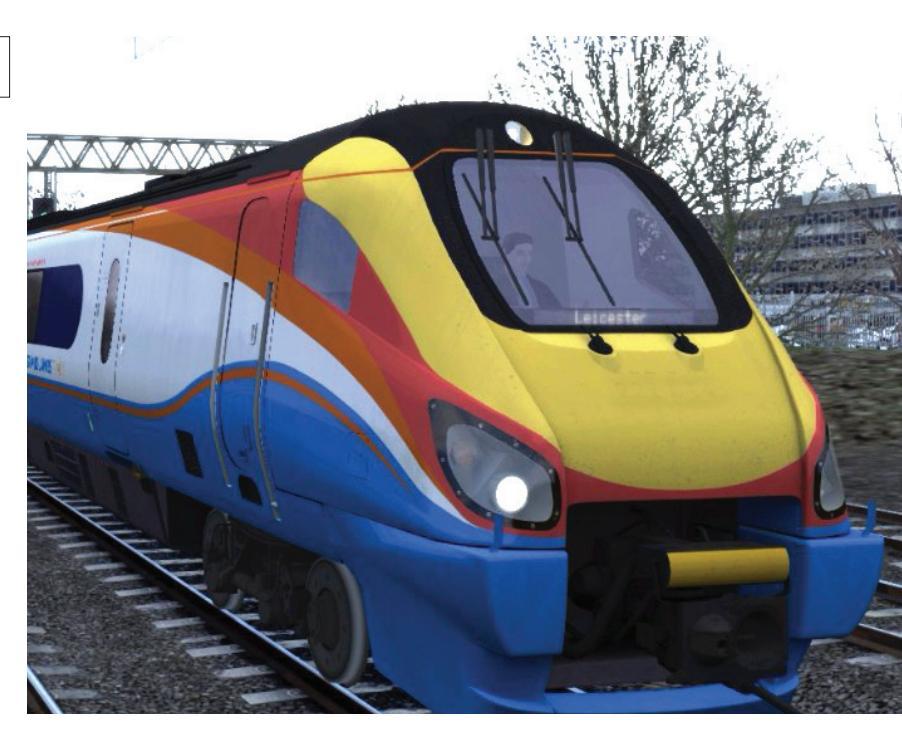
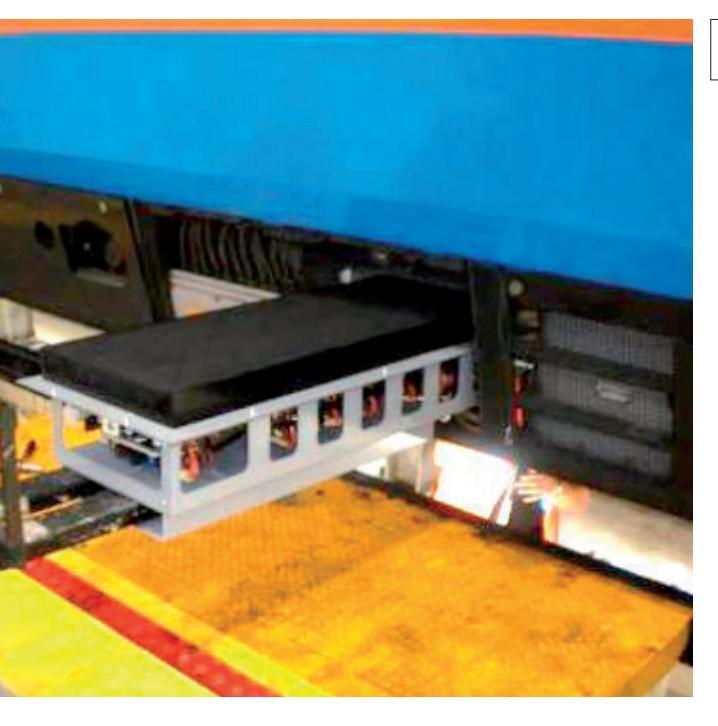
A high risk handling activity had been identified at the customer's depot where engineers have to invert traction packs before fitting.

SET designed and manufactured a turning rig.

SET specified and had produced a set of customised packing cases that ensured that equipment arrived at the depot the correct way up for their processes.
