SPECIALISTS IN ELECTRONIC & ELECTROMECHANICAL ROOT CAUSE FAULT FINDING AND RESOLUTION

Problem - Traction inverters

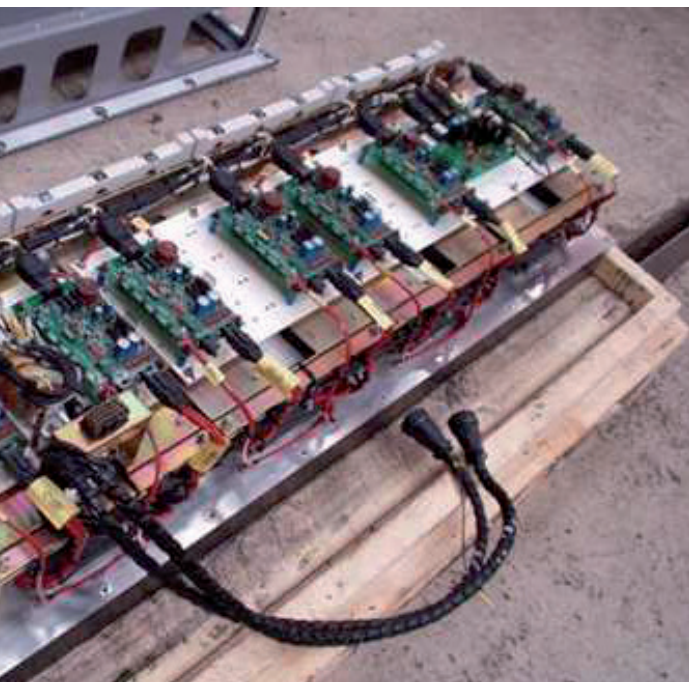
SET carried out two weeks of intensive reverse engineering and tests, which led to discovery of the root cause: a degrading internal connection within the main power switching devices (IGBTs), leading to false error detection.

- Custom test devised to detect the issue at an early stage.
- Failing IGBTs replaced with alternative batch.
- SET took over repair service from OEM

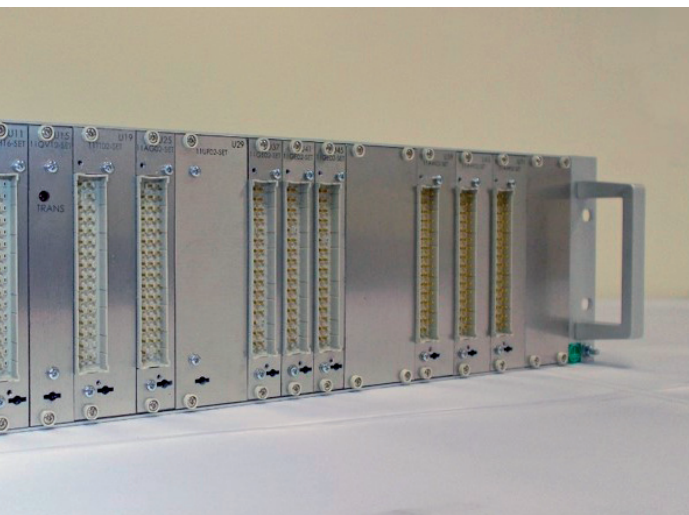
Our customer had a problem with ageing Frequency Division Multiplexer (FDM) racks. Resulting in service delays. They were looking for assistance in scoping an overhaul programme to provide maximum benefit.

- Technical report produced, based on analysis of the design and historical repair data.
- Several costed options offered, along with rationale for each.

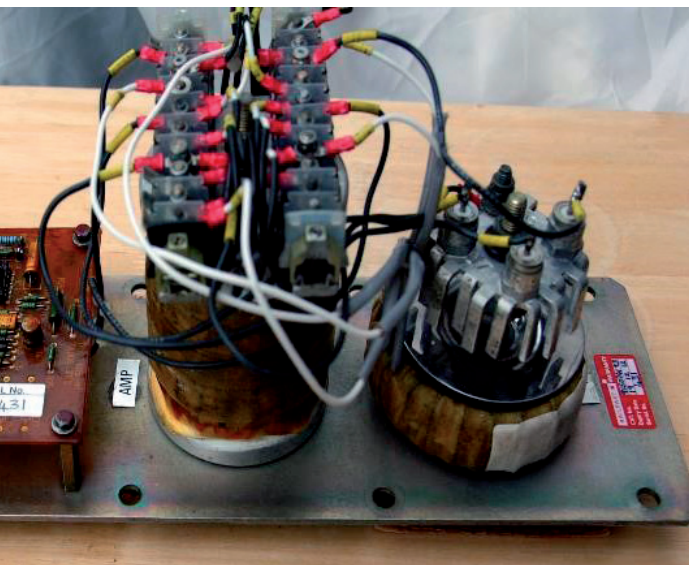
- Equipment reverse engineered to produce technical documentation and test procedure.
- Motor-alternator set built to provide required test environment and ensure that safety critical aspects could be fully verified.
- Weaknesses identified and overhaul programme devised.

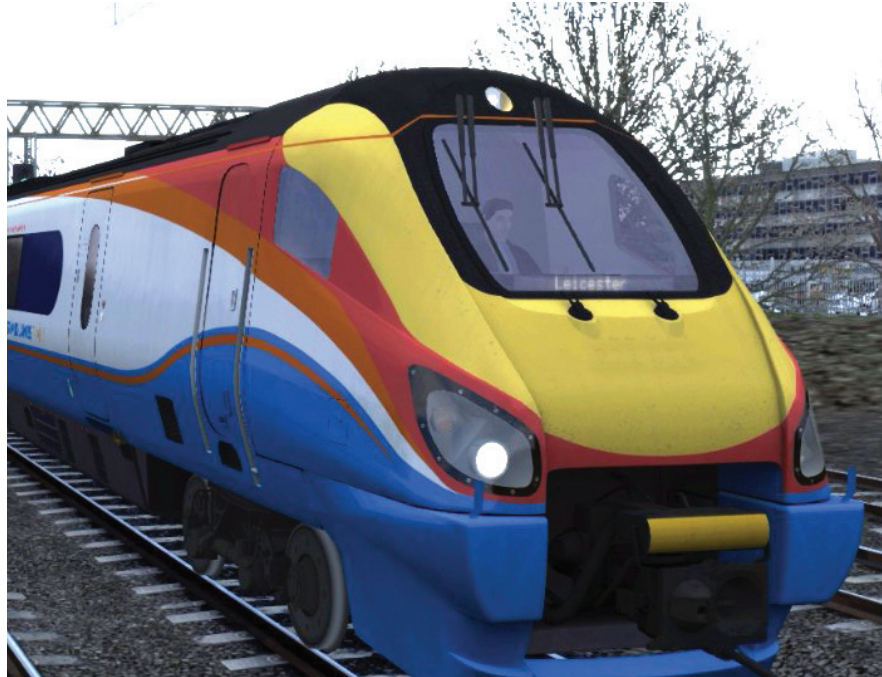
- Main power switching devices identified as 'sunset' part.
- Original part seen as 'weak'.

- Two alternatives validated via on-vehicle trials including EMC & Thermal.
- Lab tests to demonstrate operation within design limits.
- Duty cycle tests to predict service life.
- Close links established with component manufacturers to ensure all technical requirements & risks were understood. This also allowed SET models and predictions to be independently scrutinised.

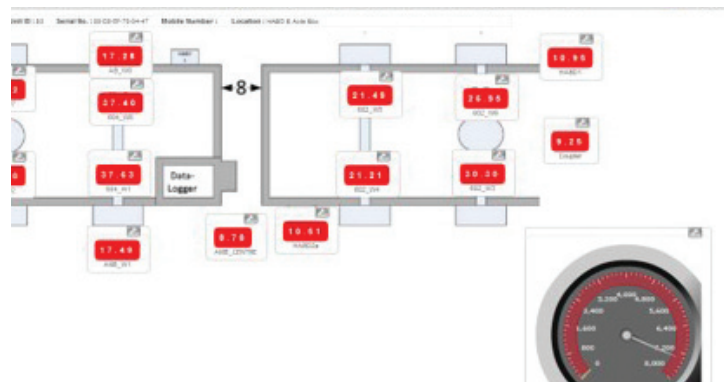
Hot axle box sensors failing partially – leading to triggering of alarm but without positive evidence of overheating. The cause and significance of this was uncertain. Service minutes were being lost.

- Report with most likely cause identified
- The proposed cause was confirmed by the sensor manufacturer who modified his process to avoid further issues
- SET report highlighted other issues for further investigation
